## Case Study: AirBurst Revitalizes Municipal Well by Removing Decade-Old Drilling Mud

Client: Municipal Utility in Central Illinois

Well: 311' deep, 10" stainless steel, 0.055" slotted screen

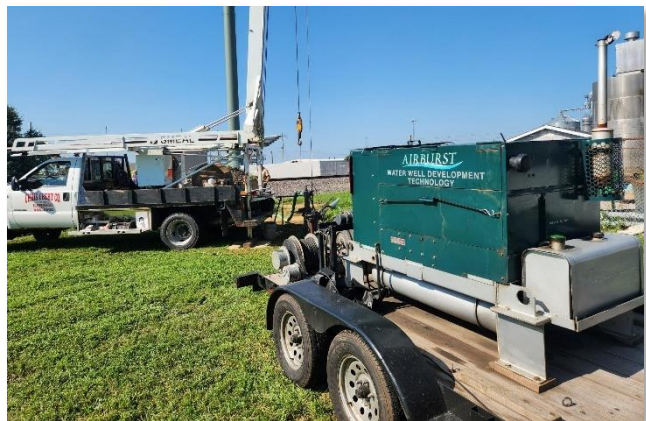
The AirBurst team arrived on-site on August 6, 2025, to execute a comprehensive rehabilitation plan. Using a 2800SL model air gun with a 40ci chamber, the crew performed five passes through the 16-foot screen interval with 0.055" slot size (295' to 311'), delivering two high-pressure bursts of compressed gas (500-1,000 PSI) per foot on each pass.

Almost immediately, the return water showed a heavy brown discharge. During subsequent pumping tests between passes, it became evident that the discharge was drilling mud that had been masked by the formation for over ten years. This discovery confirmed that the well's poor performance was directly linked to a blocked screen and formation as well as incomplete development at the time of its construction. The AirBurst process was effectively breaking up and purging the restrictive mud layer from the borehole wall and surrounding gravel pack.

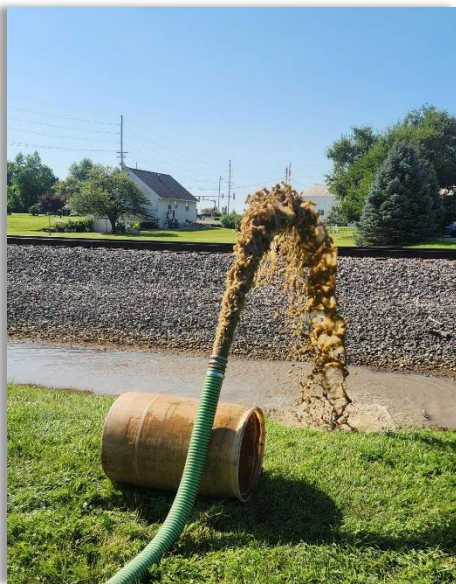
The results after the AirBurst procedure were immediate and dramatic. The well's performance was not just restored; it was elevated to a level likely never achieved before. By removing the mineral contamination and residual drilling mud, AirBurst successfully re-established a powerful hydraulic connection between the well and the aquifer. The specific capacity was increased by 115%, and the significant reduction in drawdown means the pump will operate more efficiently, leading to lower energy costs and reduced wear over time.
