Reviving a Municipal Lifeline: A 1-2 Punch Restores a major Florida drinking water well

Client: Municipal Utility in Northeast Florida

Well: 630' deep, 18" diameter open limestone well supplying drinking water

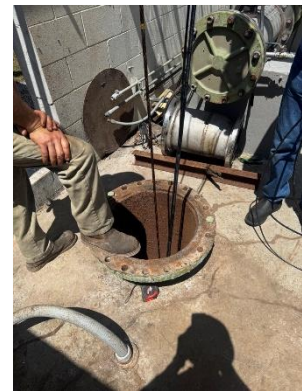
The process began with AirBurst technology. This involved lowering the 35-SL AirBurst gun into the well and releasing controlled, high-pressure pulses of gas. The resulting energy waves propagated deep into the Ocala Limestone formation to fracture brittle mineral scale, break up resilient biofilm, and reopen the network of fractures that were obstructed. This critical first step physically cleared the deep-seated blockages that chemical treatments alone could not reach.
