## Reviving a Municipal Lifeline: A 1-2 Punch Restores a major Florida drinking water well

**Client:** Municipal Utility in Northeast Florida

**Well:** 630' deep, 18" diameter open limestone well supplying drinking water

**Prime Contractor:** Complete Services

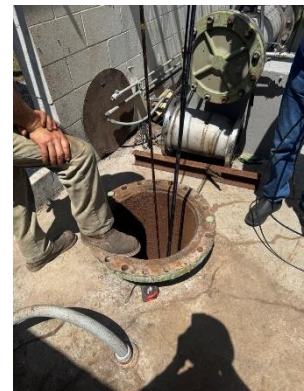
The process began with AirBurst technology. This involved lowering a specialized tool into the well and releasing controlled, high-pressure pulses of gas. The resulting energy waves propagated deep into the Ocala Limestone formation to fracture brittle mineral scale, break up resilient biofilm, and reopen the network of fractures that were obstructed. This critical first step physically cleared the deep-seated blockages that chemical treatments alone could not reach.
